# Aydın Dental Journal

## *The Closure Screw Loosening Complication of Single-Molar Implant Mimicking Peri-Implant Mucositis: A Case Report*

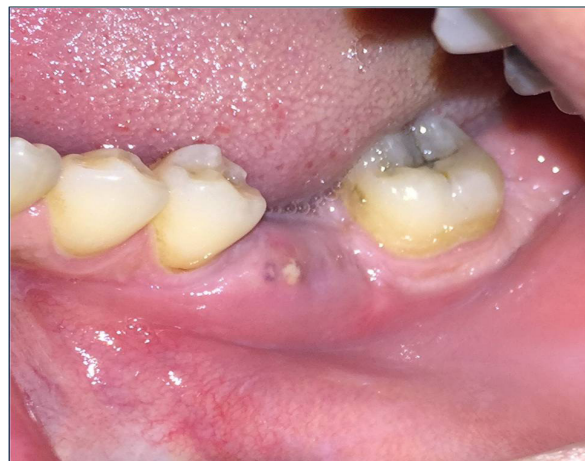
**Figure 1.** Pre-operative intraoral view of the implant side

weeks after surgery, the patient was returned with symptoms characterized by swelling, pain and inflammation on crestal mucosa of implant side (Figure 1). The closure screw loosening was occurred on the panoramic radiograph (Figure 2).

A crestal incision was made over the implant side, mobilized screw was removed and intraoral drainage was performed. After this procedure, a healing cap was placed and

incision was sutured. Medication therapy (Amoxicillin Clavulanate 1000 mg, Ibuprofen, Chlorhexidine gluconate) was started to resolution of the infection for seven days. The patient was completely asymptomatic during the healing period. Eight weeks later a panoramic radiography revealed a non-inflamed mucosa with no pathology evident. After the healing and osseointegration period of 2 months, implant retained single crown was finished (Figure 3-4). Follow-up period obtained five months later showed favorable results.
